## Infrared Thermography Survey

### The Hartford Steam Boiler Inspection and Insurance Company

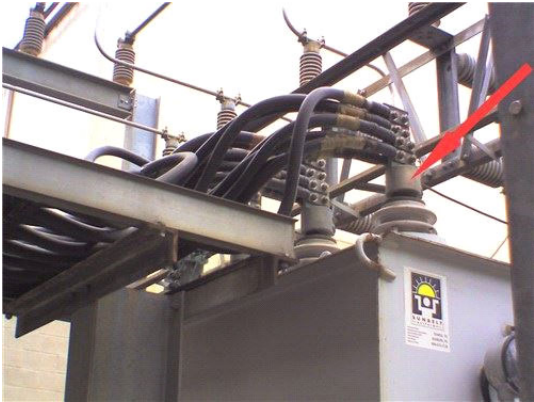
Location Area:	Outside Substation
	Equipment Location:	Main Transformer
	Est. Repair Cost Before Failure:	\$5000.00
	Est. Repair Cost After Failure:	\$78000.00
	Estimated % of Production:	100%
	Estimated Down Time:	10-14 Days

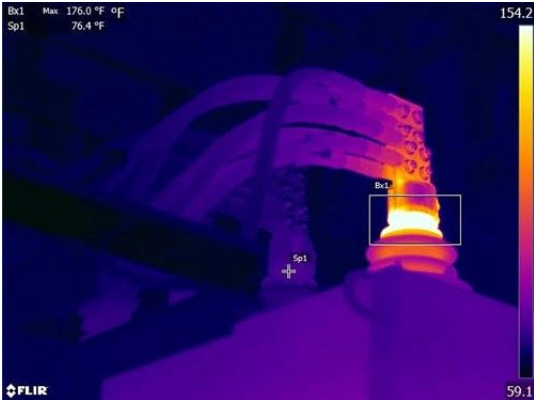
Reference Point	76.4°F
	Box 1 Max Temp	176.0°F
	Box 1 Temp Rise	99.6°F

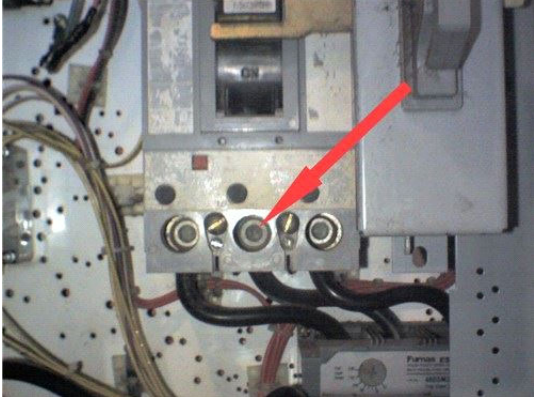
Location Area:	Raw Materials
	Equipment Location:	Pellet Feeder
	Est. Repair Cost Before Failure:	\$100.00
	Est. Repair Cost After Failure:	\$4000.00
	Estimated % of Production:	50%
	Estimated Down Time:	2 Days

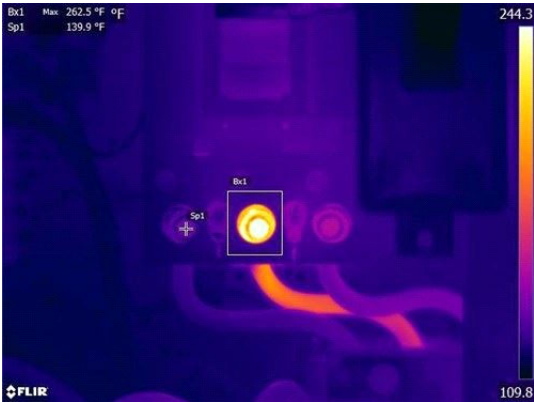
Reference Point	139.9°F
	Box 1 Max Temp	262.5°F
	Box 1 Temp Rise	122.6°F

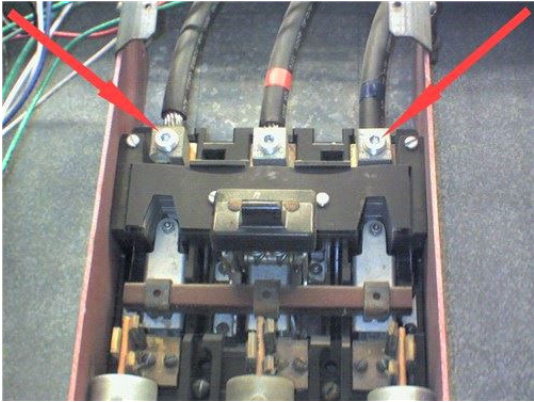
Location Area:	Press Dept.
	Equipment Location:	Pres No.22
	Est. Repair Cost Before Failure:	\$50.00
	Est. Repair Cost After Failure:	\$475.00
	Estimated % of Production:	10%
	Estimated Down Time:	1 Days

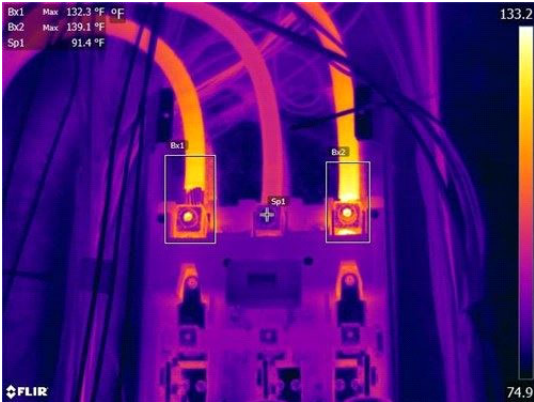
Reference Point	91.4°F
	Box 1 Max Temp	132.3°F
	Box 1 Temp Rise	40.9°F
	Box 2 Max Temp	139.1°F
	Box 2 Temp Rise	47.7°F

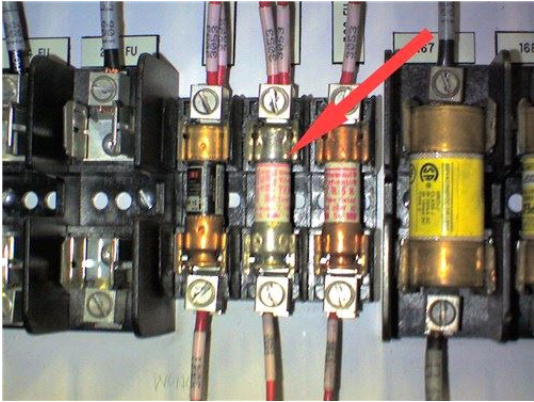
Location Area:	Packing Dept.
	Equipment Location:	Palletizer Control Panel
	Est. Repair Cost Before Failure:	\$25.00
	Est. Repair Cost After Failure:	\$40.00
	Estimated % of Production:	0%
	Estimated Down Time:	0 Days

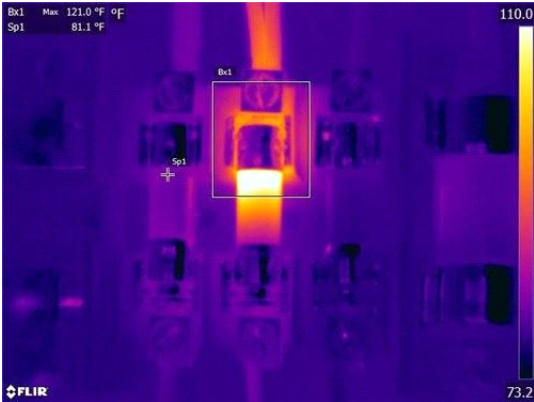
Reference Point	81.1°F
	Box 1 Max Temp	121.0°F
	Box 1 Temp Rise	39.9°F

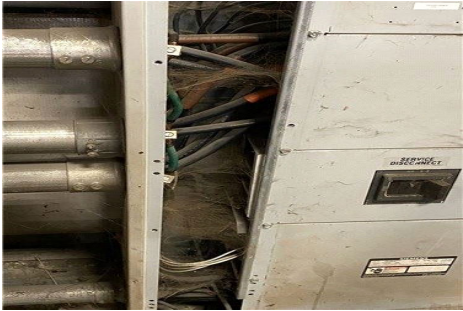
Location Area:	Assembly Dept.
	Equipment Location	By Overhead Door

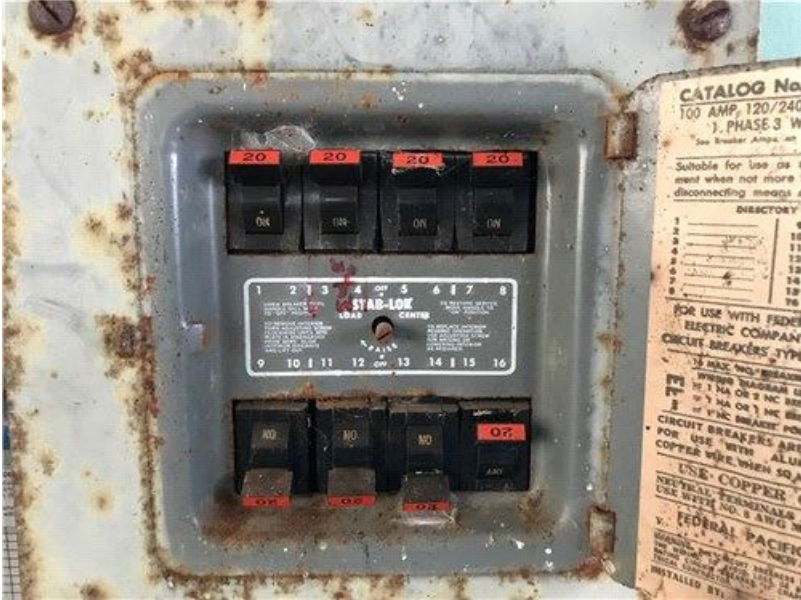
Location Area:	Warehouse
	Equipment Location	Shipping Office
