Hartford Steam Boiler

Learn From Loss College Student Housing Fire

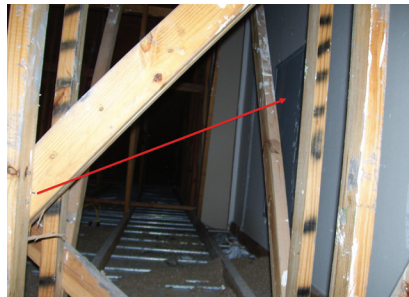
Allowed self-closing door with automatic latch in the draftstop wall of an attic.

The first person to call-in the fire saw smoke from the eaves on the north side of the building. However, when the fire truck arrived, within 6-minutes, smoke from both the north and south eaves was observed. This building had an attic space of approximately 6,000-square feet and the overall building construction was reported to be wood frame. Under these conditions, model building codes require that draftstops be installed so that attic areas do not exceed 3,000 square feet. A draftstop is a continuous membrane, usually fire rated sheetrock, used to subdivide an attic space to resist the passage of smoke and heat. The codes require that after installation, the draftstop(s) must be properly maintained. A draftstop was not addressed in the SFMO report, however smoke issuing from the attic at both ends of the building early in the fire raises the question as to the installation and/or the maintenance of a draftstop. For those who inspect buildings, one should verify that a draftstop is properly installed and that it is sufficiently maintained.

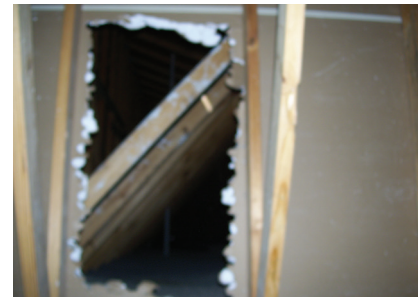
“Unapproved” opening in a draftstop wall.
