INFRARED THERMOGRAPHIC SURVEY

ABC Company, Inc.
123 Any Street
Any Town, US 12345

March 24, 2020

VIBRATION ANALYSIS SURVEY

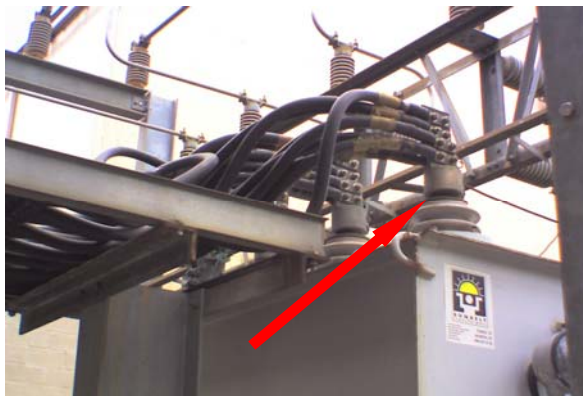
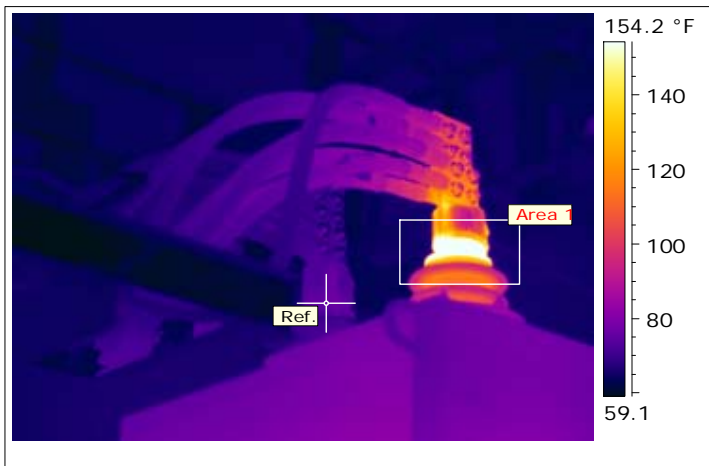
Finding No. 1 **Category** **CRITICAL**

Location Area	Outside Substation
Equipment Location	Main Transformer
Equipment ID	East Secondary Bushing
Est. Repair Cost Before Failure	\$5,000
Est. Repair Cost After Failure	\$78,000
Est. % of Production	90%
Est. Down Time	10-14 Days

Ref. Temperature	76.2 °F
Area 1 Max. Temperature	176.0 °F

Area 1: Rise	99.8 °F
--------------	---------

The thermal pattern indicates the transformer has an internal problem conducting heat out to the surface of the bushing. This should be investigated and repaired by a qualified HV electrical contractor.

*This is rated as "CRITICAL" due to the high replacement cost of the transformer and potential business interruption should a failure occur.

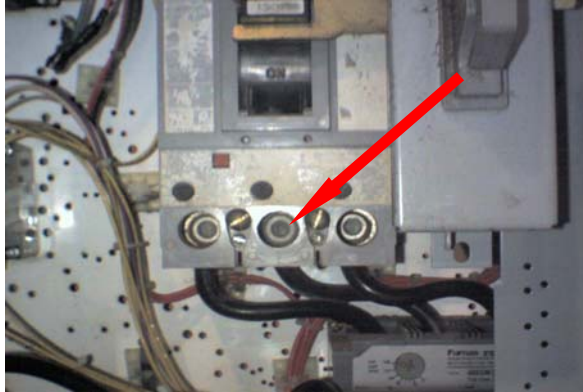
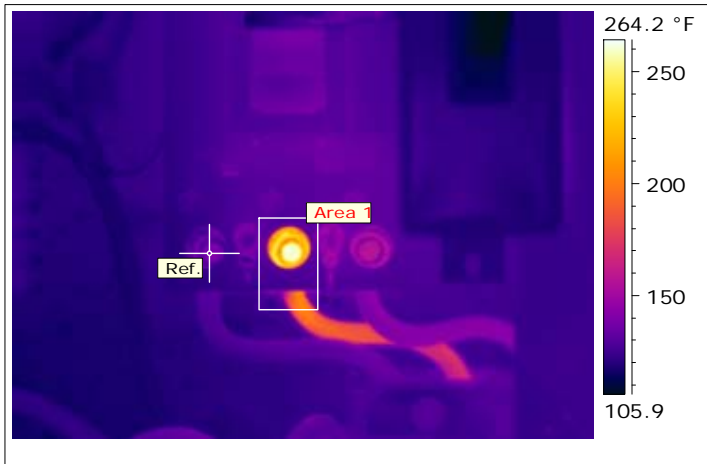
Location Area	Raw Materials
Equipment Location	Pellet Feeder
Equipment ID	Main Breaker
Est. Repair Cost Before Failure	\$100
Est. Repair Cost After Failure	\$4,000
Est. % of Production	50%
Est. Down Time	2 Days

Ref. Temperature	140.1 °F
Area 1 Max. Temperature	262.5 °F

Area 1: Rise	122.4 °F
---------------------	-----------------

*This is rated as "SEVERE" due to the very high temperature and potential business interruption.

The lug connection should be disassembled, cleaned, inspected for damage and repaired as necessary. Replace any discolored or damaged hardware and cut back the wire to sound conductor. Reassemble and torque the fastener according to the manufacturer's specifications.

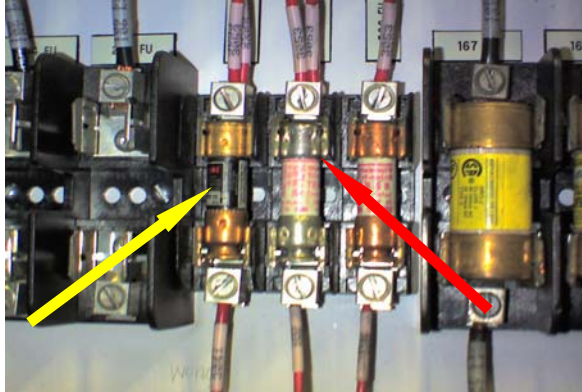
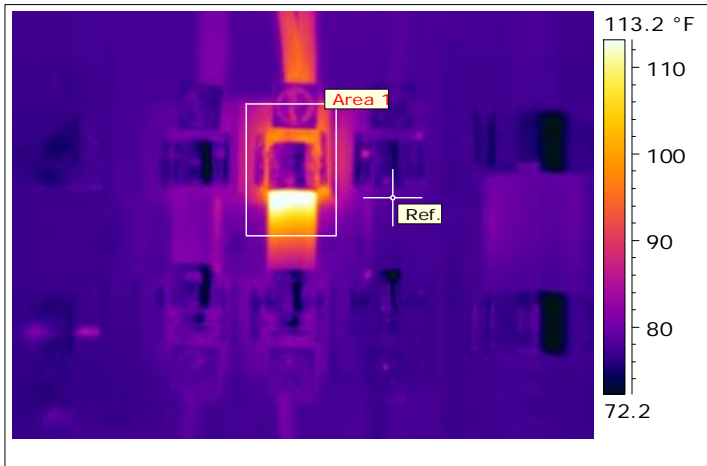
3

Location Area	Packaging Dept.
Equipment Location	Palletizer No.3
Equipment ID	Fuse No.1673
Est. Repair Cost Before Failure	\$25
Est. Repair Cost After Failure	\$40
Est. % of Production	0%
Est. Down Time	0

Ref. Temperature	78.9 °F
Area 1 Max. Temperature	121.0 °F

Area 1: Rise	42.1 °F
---------------------	----------------

Remove the fuse and clean the fuse and fuse clip. Reinsert the fuse ensuring the fuse clip is providing adequate tension and making good contact with the fuse. Also, all three fuses (yellow arrow) should be the same size, style, and type from the same manufacturer.

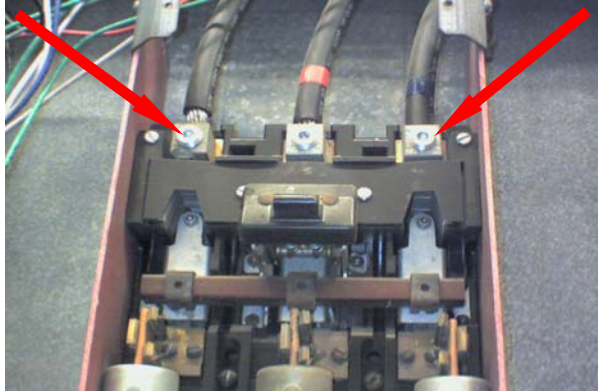
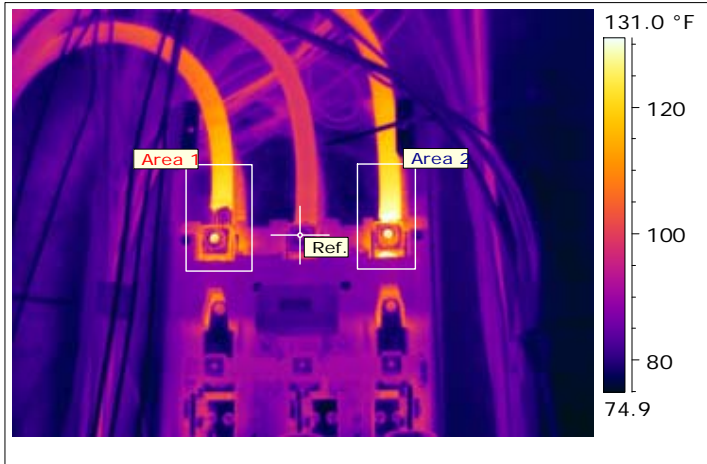
4

Location Area	Press Dept.
Equipment Location	Press No.22
Equipment ID	Disconnect
Est. Repair Cost Before Failure	\$50
Est. Repair Cost After Failure	\$475
Est. % of Production	10%
Est. Down Time	1 Day

Ref. Temperature	91.4 °F
Area 1 Max. Temperature	132.3 °F
Area 2 Max. Temperature	139.1 °F

Area 1: Rise	40.9 °F
Area 2: Rise	47.7 °F

The connections should be disassembled, cleaned, inspected for damage and repaired as necessary. Reassemble and torque fasteners according to the manufacturer's specifications using new hardware as required.

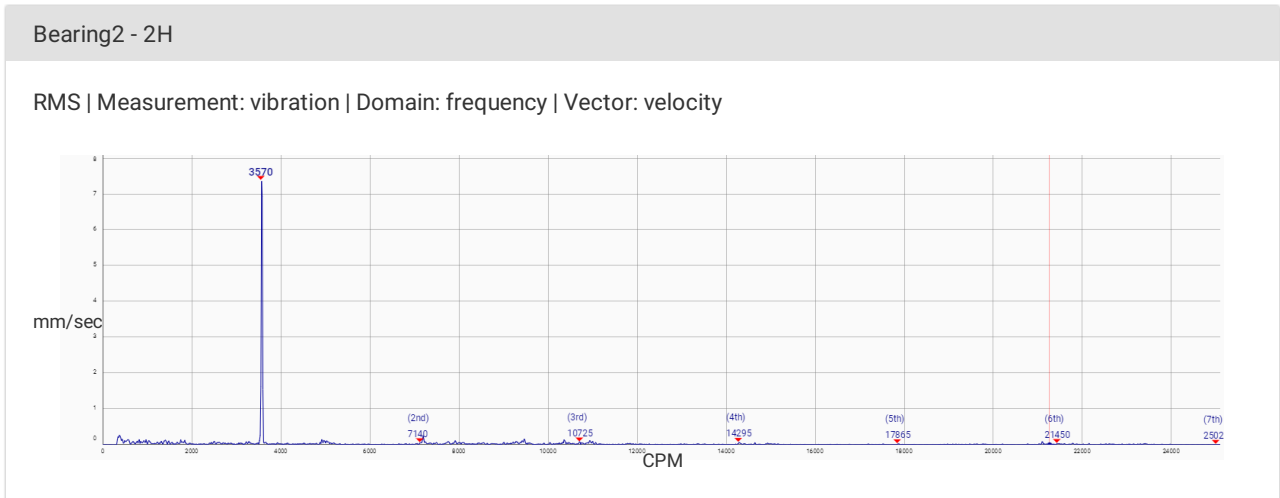
84-Fan Mold -10 - Fan
 Last Recorded Nov 12, 2019 4:05:45 PM GMT by Charlie Johnson

alarm Radial unbalance - Driven Fan

The vibration levels at the fan running speed indicate a possible fan imbalance.

<p>Possible Cause</p> <ul style="list-style-type: none"> - Heavy spot. - Dirt build-up. - Erosion of fan blades. 	<p>Maintenance Practices</p> <ul style="list-style-type: none"> - Wash and clean as access permits. - Balance the fan.
--	---

Overview
 Schedule the recommended activities in the next quarter and monitor the machine frequently until repaired.

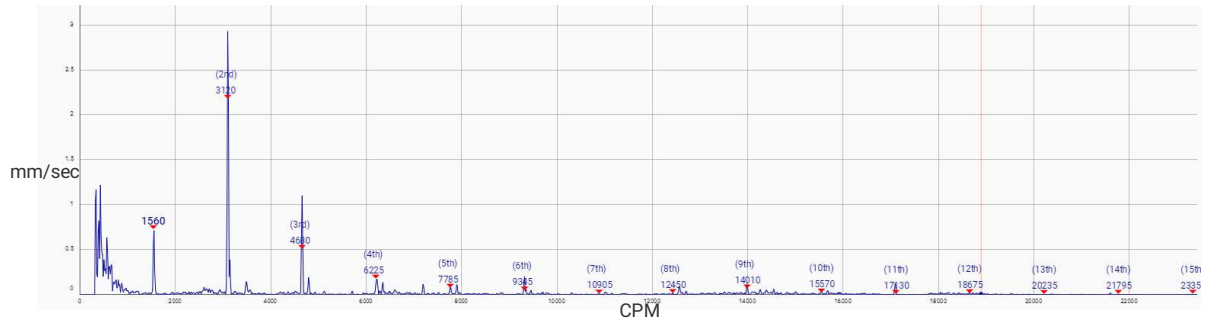
Bearing1 - 1H

Misalignment - Motor

Misalignment between the motor and the machine.

- Damaged or worn shaft or coupling.
- Pipe strain
- Soft foot
- Incorrect thermal growth offset
- Imprecise installation / maintenance practices

- Inspect coupling for wear.
- Consider performing a precision shaft alignment.
- Continue to monitor.

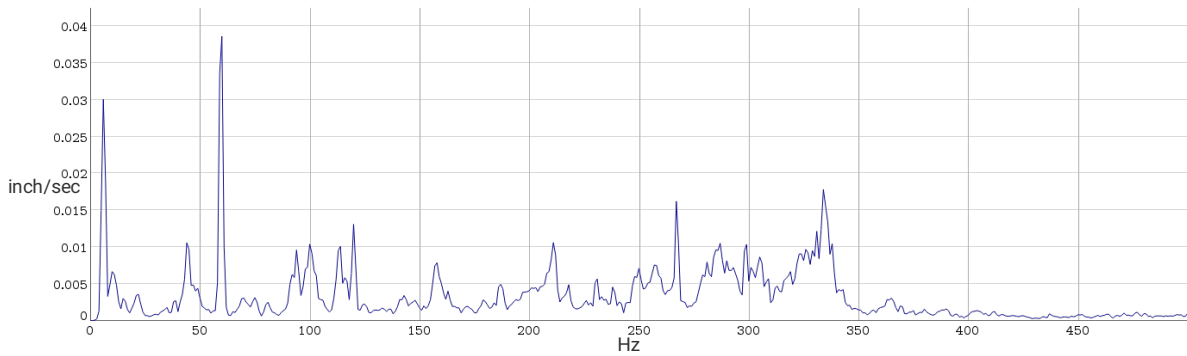
Bearing1 - 1H

Continue with usual maintenance activities and monitoring on a regular basis.
