INFRARED THERMOGRAPHIC SURVEY

ABC Company, Inc.

Survey Performed

April 4, 2018

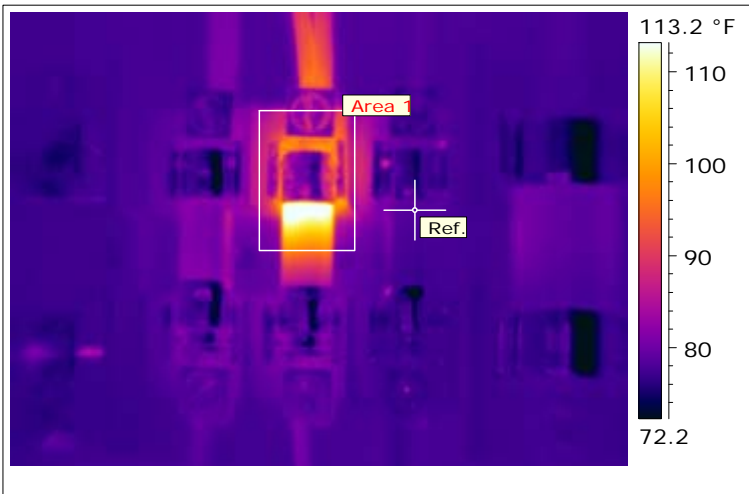
3

Location Area	Packaging Dept.
Equipment Location	Palletizer No.3
Equipment ID	Fuse No.1673
Est. Repair Cost Before Failure	\$25
Est. Repair Cost After Failure	\$40
Est. % of Production	0%
Est. Down Time	0

Ref. Temperature	78.9 °F
Area 1 Max. Temperature	121.0 °F

Area 1: Rise	42.1 °F
---------------------	----------------

Remove the fuse and clean the fuse and fuse clip. Reinsert the fuse ensuring the fuse clip is providing adequate tension and making good contact with the fuse. Also, all three fuses (yellow arrow) should be the same size, style, and type from the same manufacturer.

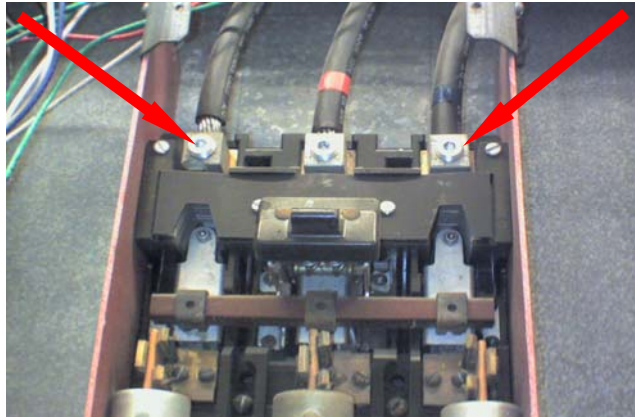
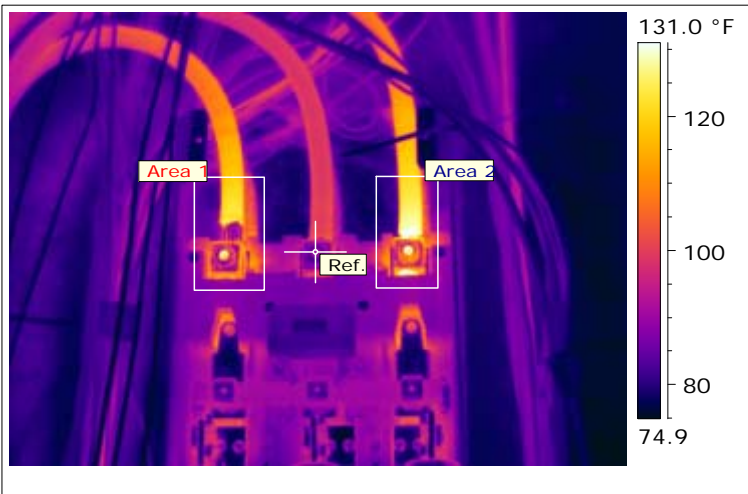
4

Location Area	Press Dept.
Equipment Location	Press No.22
Equipment ID	Disconnect
Est. Repair Cost Before Failure	\$50
Est. Repair Cost After Failure	\$475
Est. % of Production	10%
Est. Down Time	1 Day

Ref. Temperature	91.4 °F
Area 1 Max. Temperature	132.3 °F
Area 2 Max. Temperature	139.1 °F

Area 1: Rise	40.9 °F
Area 2: Rise	47.7 °F

The connections should be disassembled, cleaned, inspected for damage and repaired as necessary. Reassemble and torque fasteners according to the manufacturer's specifications using new hardware as required.
