INFRARED THERMOGRAPHIC SURVEY

ABC Company, Inc.

Survey Performed

January 31, 2019

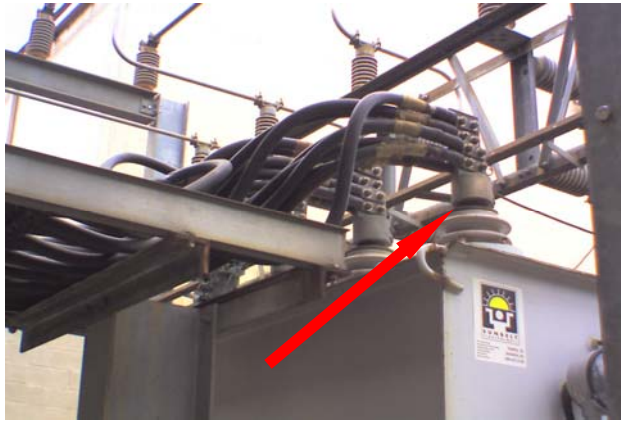
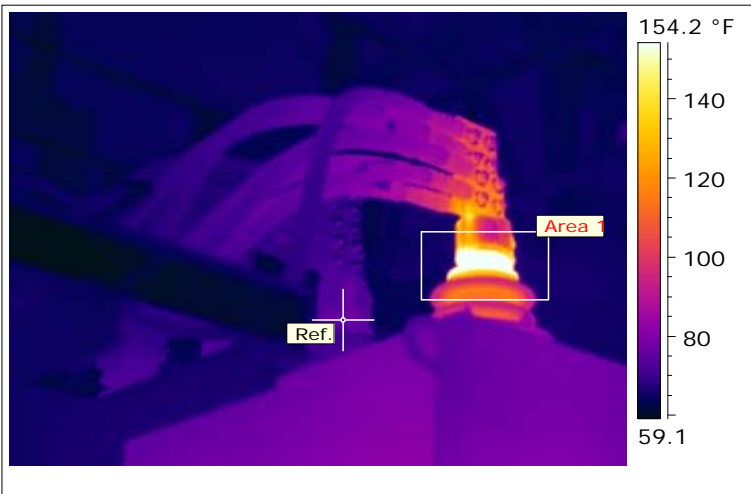
Location Area	Outside Substation
Equipment Location	Main Transformer
Equipment ID	East Secondary Bushing
Est. Repair Cost Before Failure	\$5,000
Est. Repair Cost After Failure	\$78,000
Est. % of Production	90%
Est. Down Time	10-14 Days

Ref. Temperature	76.2 °F
Area 1 Max. Temperature	176.0 °F
Area 1: Rise	99.8 °F

The thermal pattern indicates the transformer has an internal problem conducting out to the surface of the bushing. This should be investigated and repaired by a qualified HV electrical contractor.

*This is rated as “CRITICAL” due to the high replacement cost of the transformer and potential business interruption should a failure occur.

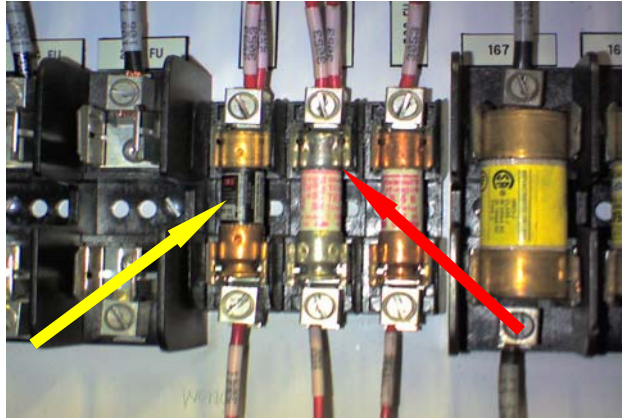
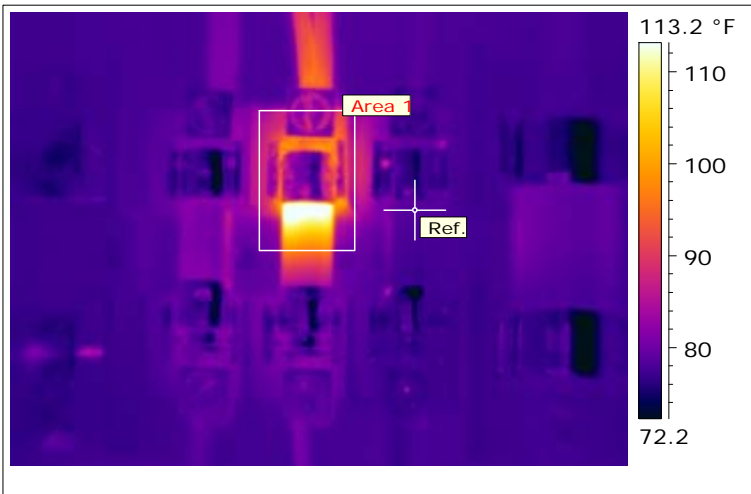
3

Location Area	Packaging Dept.
Equipment Location	Palletizer No.3
Equipment ID	Fuse No.1673
Est. Repair Cost Before Failure	\$25
Est. Repair Cost After Failure	\$40
Est. % of Production	0%
Est. Down Time	0

Ref. Temperature	78.9 °F
Area 1 Max. Temperature	121.0 °F

Area 1: Rise	42.1 °F
---------------------	----------------

Remove the fuse and clean the fuse and fuse clip. Reinsert the fuse ensuring the fuse clip is providing adequate tension and making good contact with the fuse. Also, all three fuses (yellow arrow) should be the same size, style, and type from the same manufacturer.

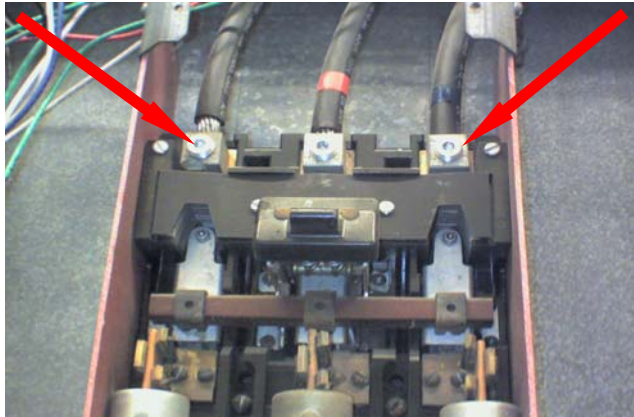
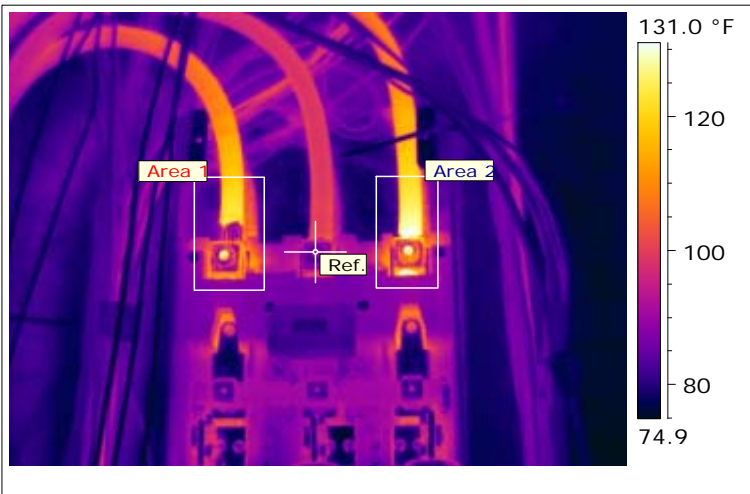
4

Location Area	Press Dept.
Equipment Location	Press No.22
Equipment ID	Disconnect
Est. Repair Cost Before Failure	\$50
Est. Repair Cost After Failure	\$475
Est. % of Production	10%
Est. Down Time	1 Day

Ref. Temperature	91.4 °F
Area 1 Max. Temperature	132.3 °F
Area 2 Max. Temperature	139.1 °F

Area 1: Rise	40.9 °F
Area 2: Rise	47.7 °F

The connections should be disassembled, cleaned, inspected for damage and repaired as necessary. Reassemble and torque fasteners according to the manufacturer's specifications using new hardware as required.
