UNDERSTANDING

BY JOHN WEBER, The Hartford Steam Boiler Inspection and Insurance Company

One common type of service equipment switch used by a wide range of facilities is the bolted pressure switch. By evaluating the results of a catastrophic bolted pressure switch failure, the importance of proper service equipment maintenance becomes evident.

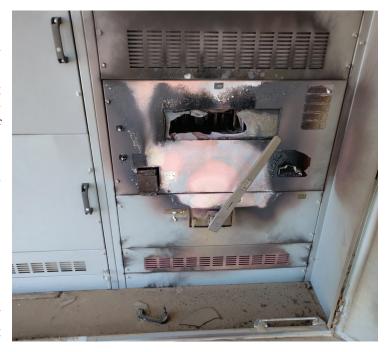
No business owner wants to respond to an emergency call at their facility to find a bolted pressure switch failure. The bolted pressure switch failure shown in this photo occurred catastrophically with all of the consequences described previously.

The proactive review and execution of main switch maintenance requirements can help prevent switch failures, power outages, and costly business interruptions.

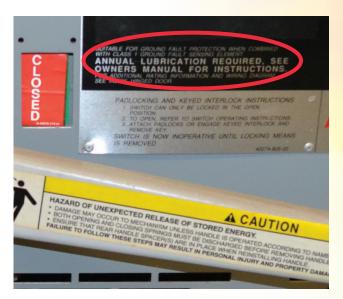
Annual lubrication is stressed by the manufacturer on this nameplate. Many owners and facility managers believe that the main switch is "maintenance-free."

As an example, bolted pressure switch manufacturers typically require annual inspection and lubrication of the conductive blade parts and the operating mechanism. Depending on the presence of adverse environmental conditions, such as excessive temperatures or dirty or wet conditions, more frequent inspection and maintenance may be required. If a bolted pressure switch is involved in an event where fuses have blown or if it has interrupted a ground fault, a complete switch inspection should be performed. One manufacturer states that, after a switch has interrupted a fault, switch design standards indicate that an unserviced switch is not suitable for reuse. After a fault opening, contaminated lubrication may need to be removed. Pitting, splatter and weld marks may need to be addressed. In addition, arc quenchers and barriers may need inspection and repairs. Contamination from the fault may prevent proper future operation of the opening and closing mechanisms. Each manufacturer provides additional details for the type of lubricants to use for the cleaning and re-lubrication process to follow. Even though a riveted nameplate was installed with large font size and bold lettering to stress the requirement of annual lubrication, the proper maintenance was not performed. Note that the instructions use the word required versus recommended.

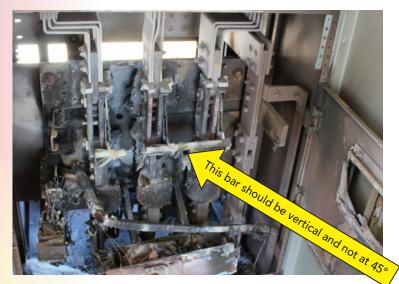
Lack of proper maintenance prevented this switch from closing and clamping completely.

The insulated crossbar picture shown here indicates that the crossbar arm did not complete its stroke. The bar is at a 45-degree angle. It should be in the vertical position when fully closed and clamped. If the required maintenance is not performed, an event like the one seen in this photo can occur.

In this case, the switch mechanism did not complete its full stroke to close the blades and clamp them properly. As a result, the switch operated with high contact resistance at all six of the unclamped switch blade locations. High amperage on the main switch caused excessive heat to occur on the blades. This became a worsening condition with increased heating and increased resistance over time. The loose, overheated connections began arcing. Typically, arcing in a nominal 480-volt switch will result

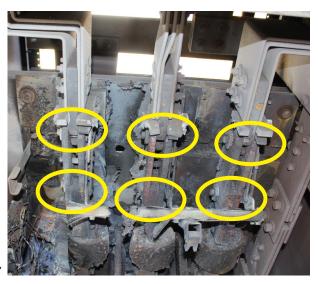
The six un-clamped switch joints operated with high contact resistance. Excessive heat and arcing destroyed this bolted pressure switch.

in phase-to-ground and phase-to-phase arcing faults. Arcing faults can destroy the switchgear enclosures and the internal switchgear components. The arcing burned a hole through the thick metal mounting plate for this switch. Many owners may not be aware of the arcing fault phenomenon and the degree of equipment destruction associated with arcing faults.

Once established, arc faults tend to travel in a direction moving away from the source. This is caused by the magnetic forces acting between the arc itself and the magnetic flux produced in the busbars. This effect is similar to the electromagnetic forces that cause a motor shaft to rotate. The arc will travel at varying speeds depending on the fault current developed. When the fault currents are over 5,000 amperes, the fault can produce a gunblast noise. An arcing fault will do the most damage at locations where the arc is physically restrained from traveling due to barriers. In the pair of photos shown here, the insulated fuse sleeves restrained the physical travel of the arc. The intense heat of the arc burned away the thick, switch mechanism crossbar and the insulated switch-mounting panel.
