LOSS BULLETIN

Operator Error Damages Boring Mill

Loss Bulletin
Number 13

**The Boiler Inspection and
Insurance Company of Canada**

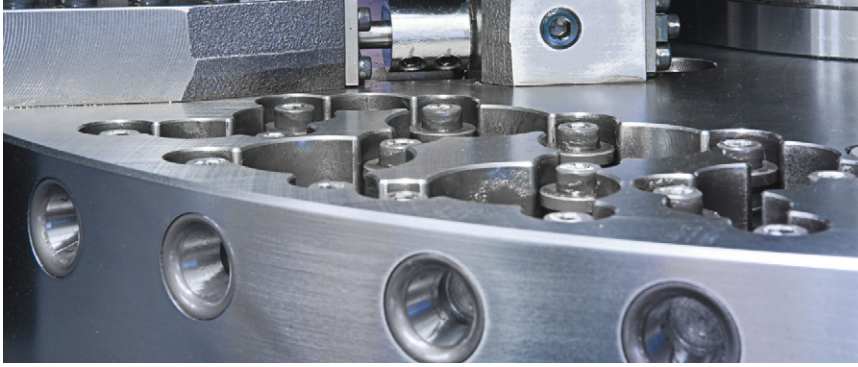
The operator of this machine had changed the machine to manual control to drill holes horizontally in the workpiece. As the cutting head was being withdrawn from one of the holes being machined, the operator proceeded to move the cutting head to the location of the next hole. In his haste, the operator neglected to ensure that the cutting head was fully withdrawn before the assembly was moved vertically. The collision resulted in extensive damage to the cutting head spindle and ceramic shaft bearings.

Despite the fact that repairs were fully expedited, it still took almost two months to obtain the replacement spindle assembly from the foreign-based manufacturer.
