Home systems loss examples

Loss bulletin

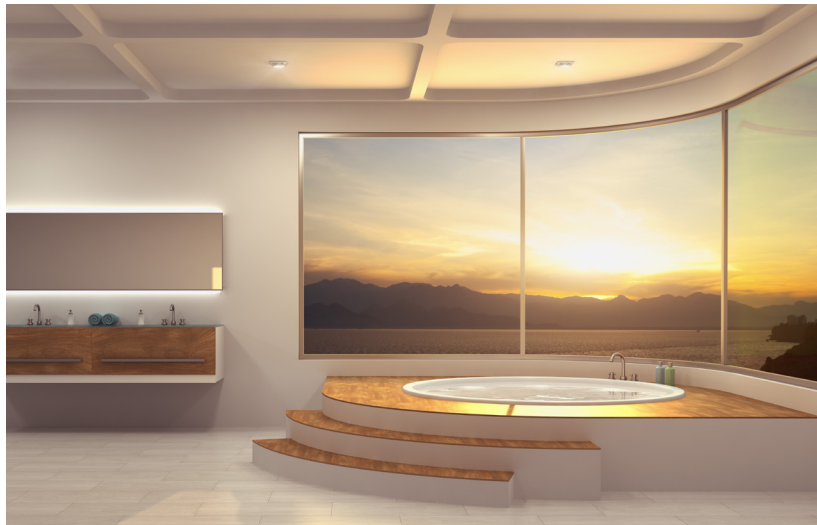
A hot tub suffered a mechanical failure to the pump discharge housing from excessive vibration.

- Cost of replace the pump: \$600
- Custom marble and tile work required to access the pump: \$1,200
- Total loss: \$1,800

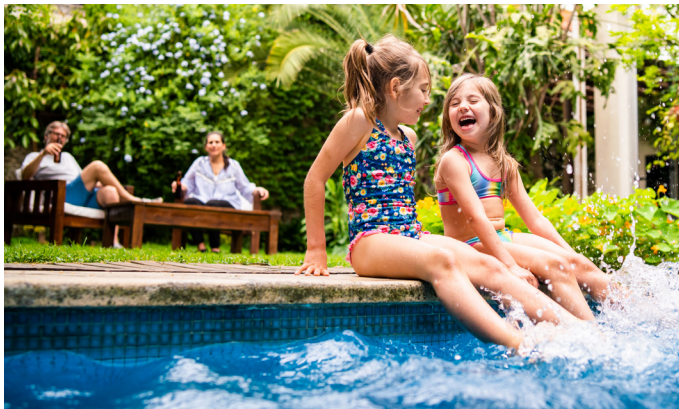
The tube in a propane-powered water heater ruptured, resulting in the need to replace the water heater.

- Replacement cost of new installed heater: \$2,500
