Rupture in condensing unit caused refrigerant to escape Equipment breakdown loss

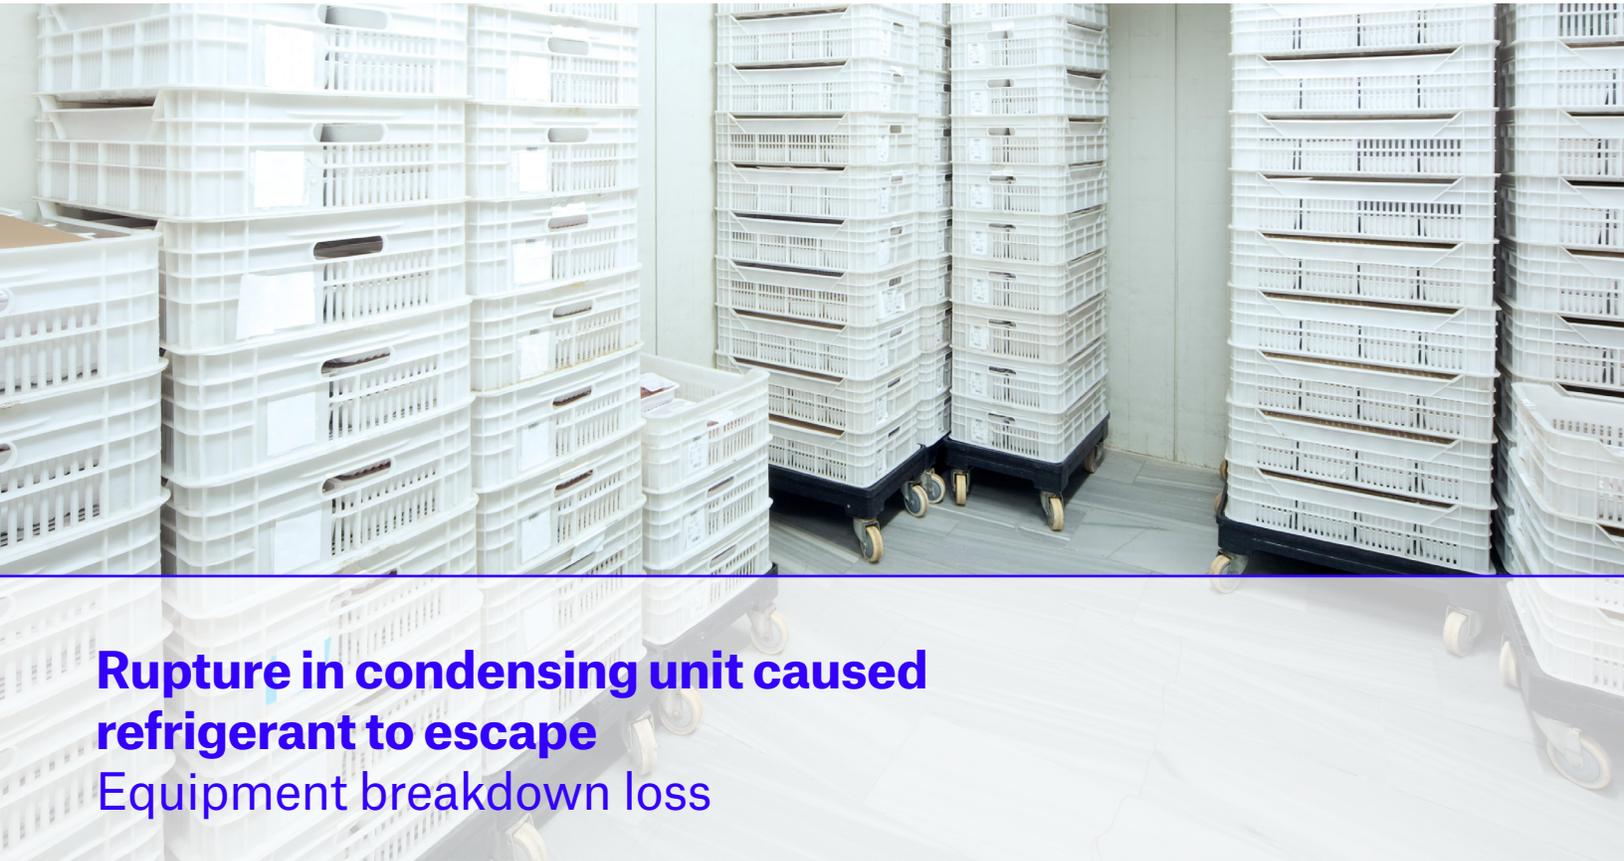
Insured discovered that the compressor had stopped and the temperature in the freezer had risen to about 50°F and the stored meat in the walk-in-freezer had thawed. Upon investigation it was discovered that a rupture in the copper piping from the condensing unit caused refrigerant to escape. This occurrence appears to be the result of constant vibration causing the pipe to rub against the casing and a small perforation to develop. The pipe was repaired and the unit was re-charged and returned to service.
