INFRARED THERMOGRAPHIC SURVEY

ABC Company, Inc.
123 Any Street
Any Town, US 12345

March 24, 2020

VIBRATION ANALYSIS SURVEY

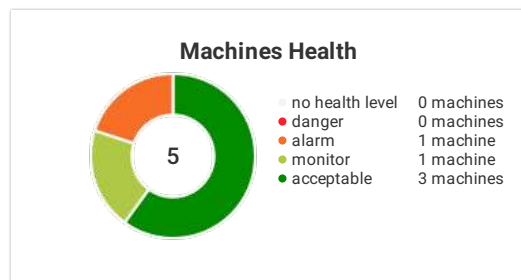
Health	Machine	Last Recorded	Faults	Type
1	Alarm	84-Fan Mold -10	Nov 12, 2019 GMT	Radial unbalance - Driven Fan	
2	Monitor	Shop 31 Mold Cooling Fan	Nov 12, 2019 GMT	Misalignment - Motor	
3	Acceptable	84-Fan Mold-12	Nov 12, 2019 GMT		
4	Acceptable	84-Fan Mold-7	Nov 12, 2019 GMT		
5	Acceptable	Shop 32 Mold Cooling Fan	Nov 12, 2019 GMT
