## LOSS BULLETIN

### EQUIPMENT BREAKDOWN LOSS

Hot Water Storage Tank Experienced  
Over-Pressure Condition

**Loss Bulletin**  
Number 14

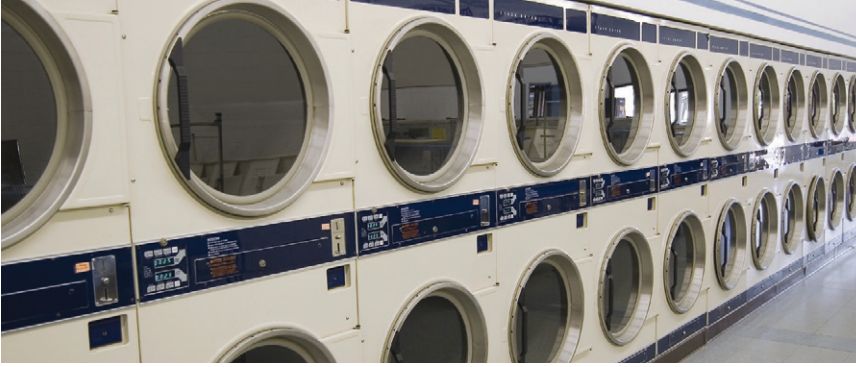
At this popular laundromat the fired hot water storage tank experienced an over-pressure condition and the hand-hole cover blew off. The force from the steam and water discharged from the tank blew the tank about 20 feet from its installed location. The tank and steam knocked down walls and ceiling tiles and damaged numerous washers and dryers. Two people in the laundromat were treated in the hospital for minor cuts and bruises.

Control failure caused this over-pressure condition. The hot water storage tank developed excessive pressure until the welds between the shell and the hand-hole flange sheared. The safety valve did not function to relieve the excess pressure. The time required to repair the building and equipment was 30 days. Business interruption coverage was not purchased.
