Dry cleaner's boiler experiences rupture, causing shutdown of operation

Equipment breakdown loss

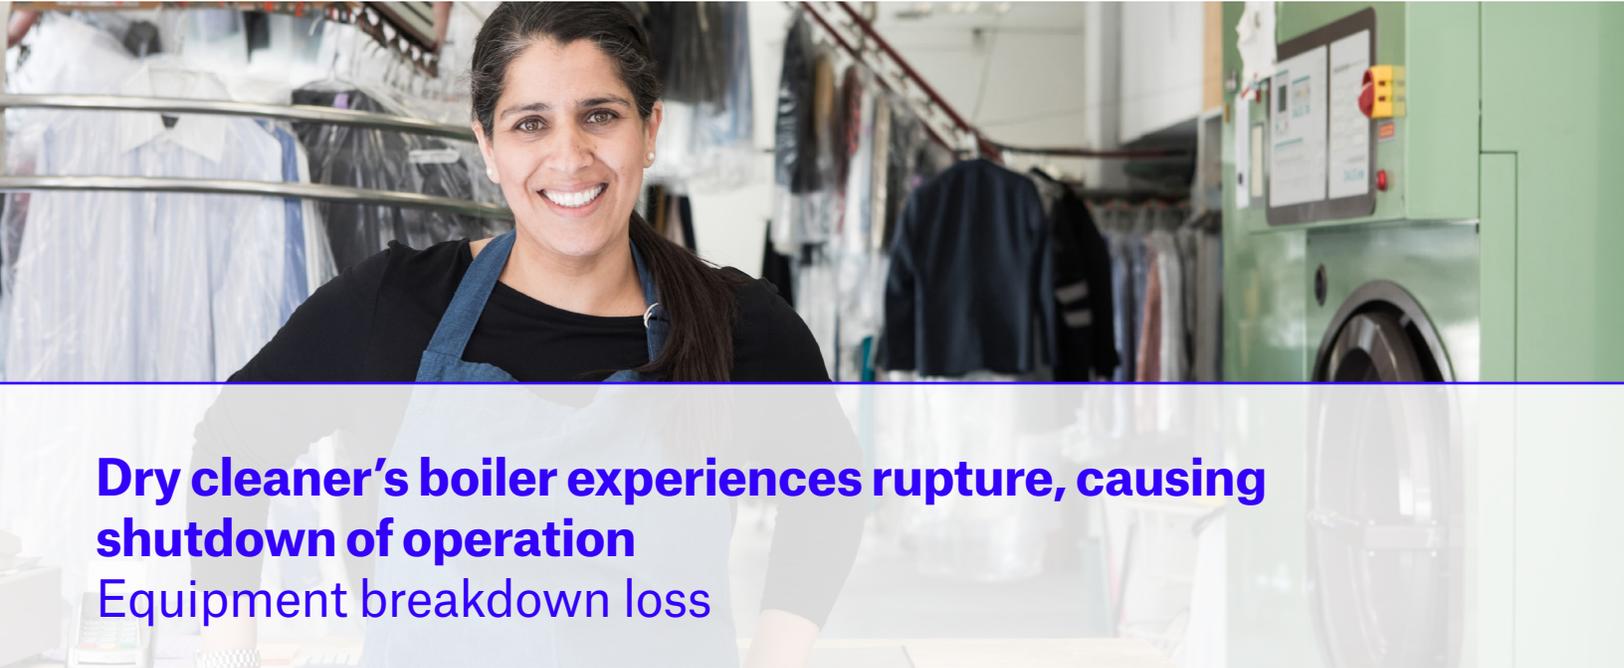
During an inspection of this boiler, which provided 100-psi steam to clothing presses, an eight-inch bulge was discovered. It was located inside, on the waterside of the boiler and caused a one-inch crack on the inner shell weld. This is a common occurrence due to heavy scale and sediment buildup.

It was determined, in the best interest of the insured, to replace this boiler with a new one within seven days, rather than repair it, taking three weeks. In the replacement process, walls within the dry cleaner were removed and reinstalled, allowing access. To prevent a reoccurrence, daily blowdowns and a water treatment plan were instituted by the insured.
